Title: Report on Western Juniper Doors Equalized at 8% and 2.5% Moisture Content for Connolly Wood Products, Bend, OR. December, 1997
 Author: James E. Reeb, Wood Products Extension Specialist, Oregon State University.

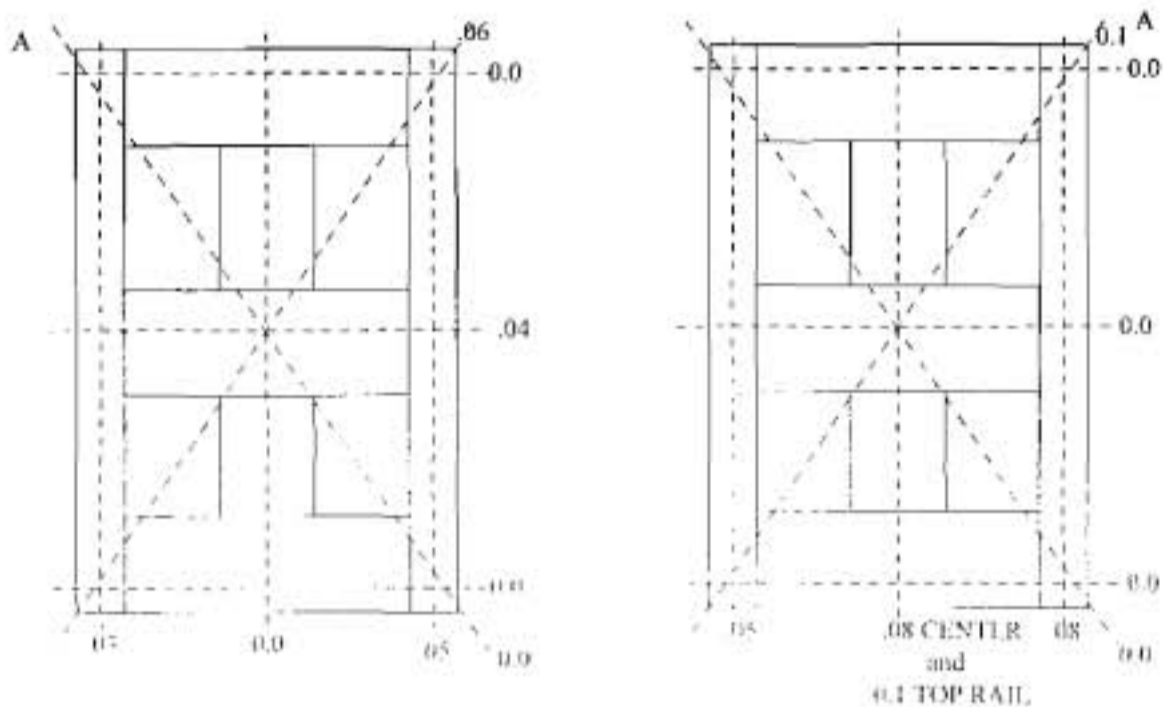
Figures 1a and 1b. Simplified drawing of finished door (8% MC). Dashed lines represent stretched wire. Values are measured maximum deviation under the wire. "A" represents same top corner.

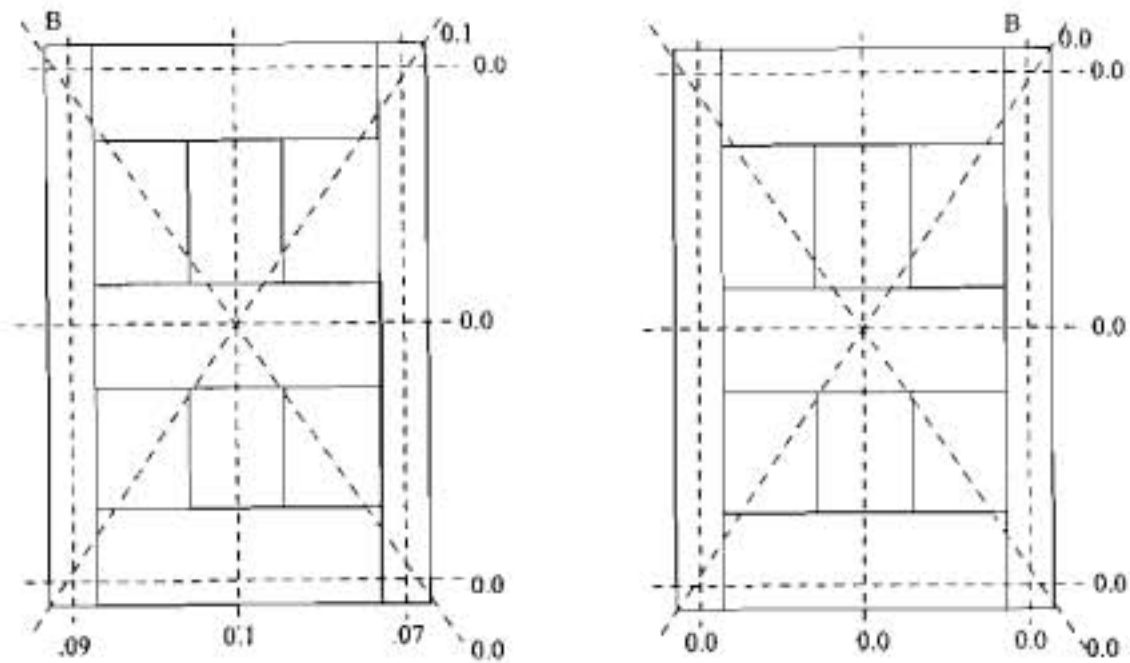
Figures 2a and 2b. Simplified drawings of unfinished door (8% MC). Dashed lines represent stretched wire. Values are measured maximum deviation under the wire. "B" represents same top corner.

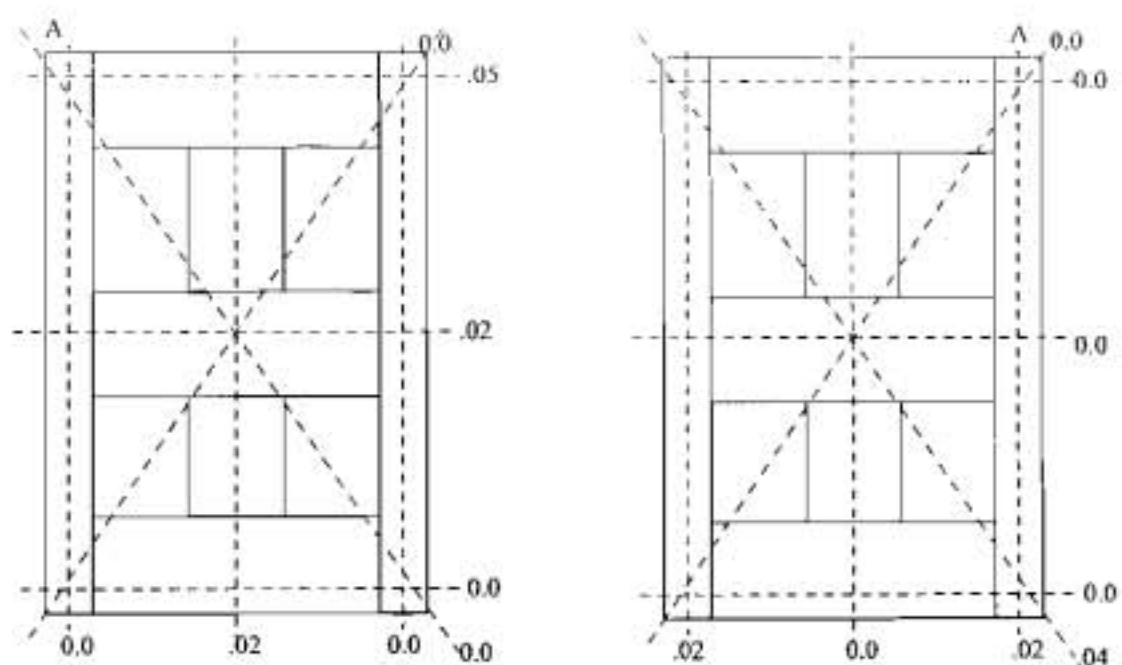
Figures 3a and 3b. Simplified drawings of finished door (2.5% MC). Dashed lines represent stretched wire. Values are measured maximum deviation under the wire. "A" represents same top corner.

Initially, we thought the doors probably warped because the wood was exposed to a dryer environment than that in which the doors had been constructed, warp due to the wood losing moisture and shrinking across the grain. However, observation and measurements showed that the finished door relaxed somewhat in the low EMC (equilibrium moisture content) conditions. Except for the stiles (.07 to 0 and .09 to .04, Figures 2a and 4a), the unfinished door did not change much from 8% MC to 2.5% MC. Does this mean that the doors (particularly the finished door) were manufactured in extremely low EMC conditions? If the doors were built with wood conditioned in Bend at a low humidity (2 - 3% EMC would not be unreasonable in heated winter conditions), then sent to a dry site in Montana, the dry site could still have EMC conditions greater than 5% above those from the manufacturing facility. For example, a relative humidity range of 10 - 15% and temperature range of 60 - 90 degrees F would equate to EMC conditions ranging from about 2.3% to 3.6%.

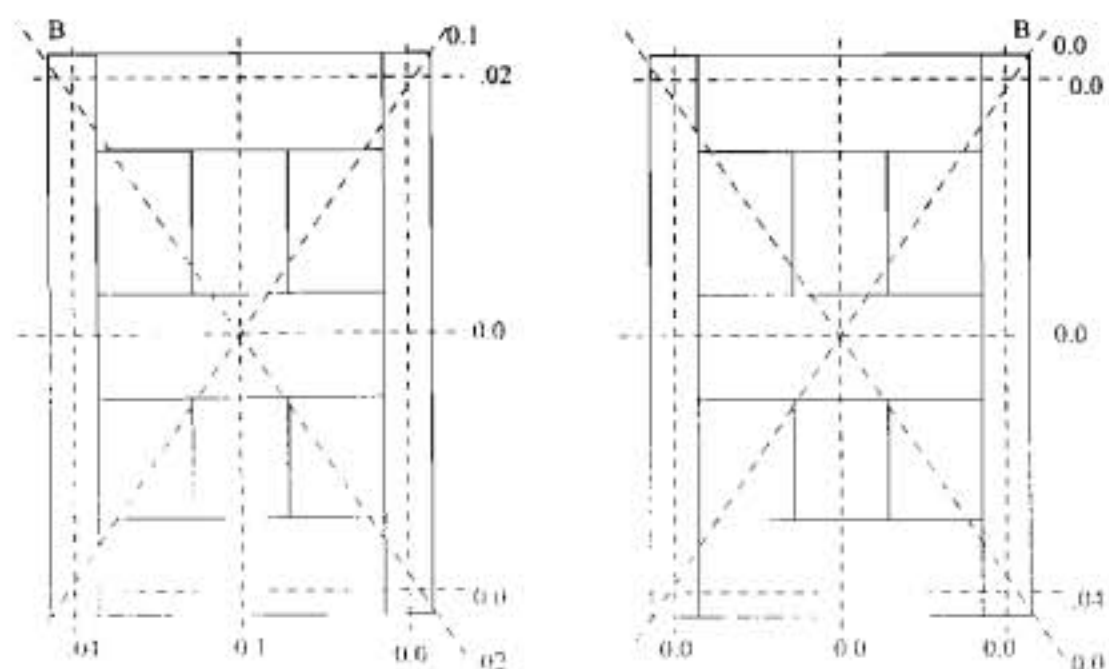
Figures 4a and 4b. Simplified drawings of unfinished door (2.5% MC). Dashed lines represent stretched wire. Values are measured maximum deviation under the wire. "B" represents same top corner.

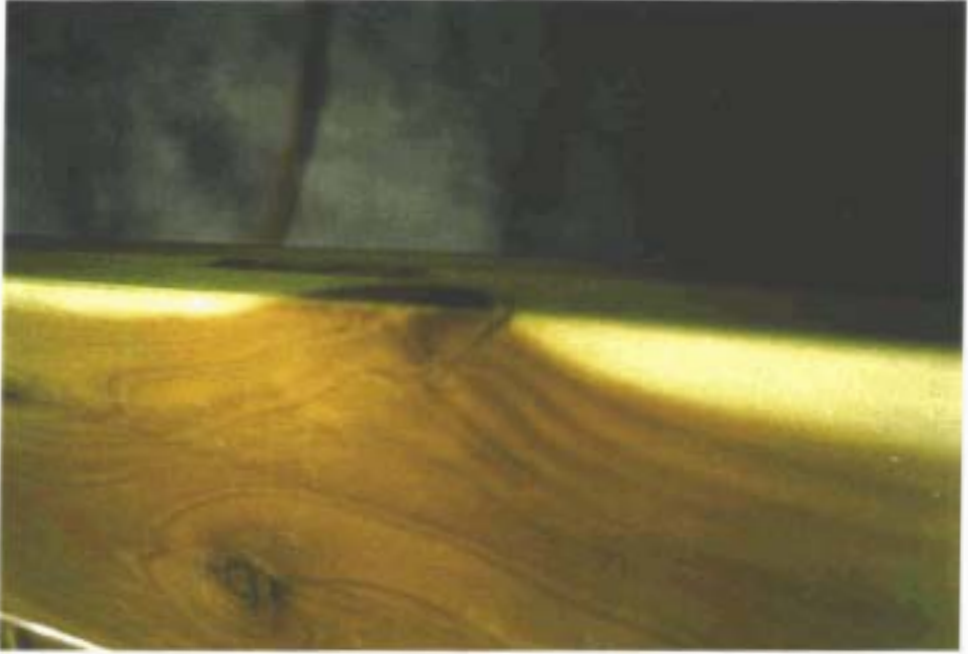
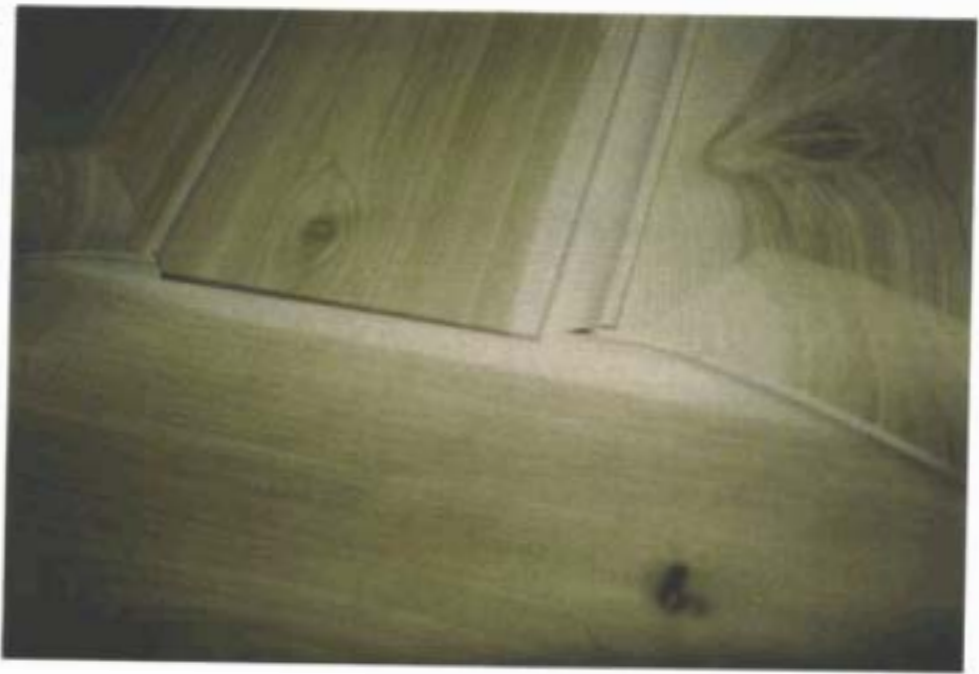
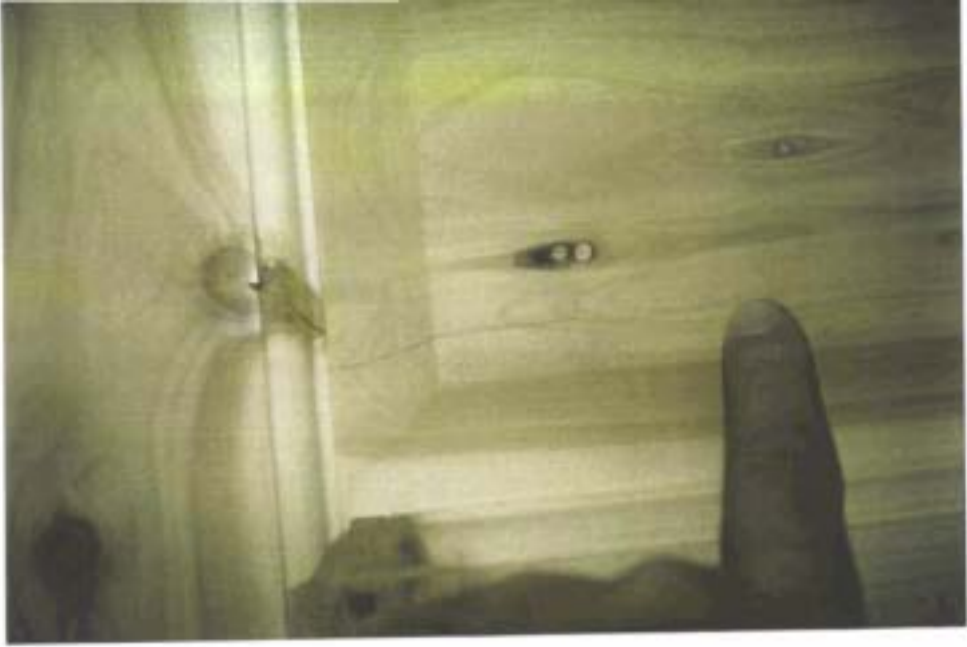
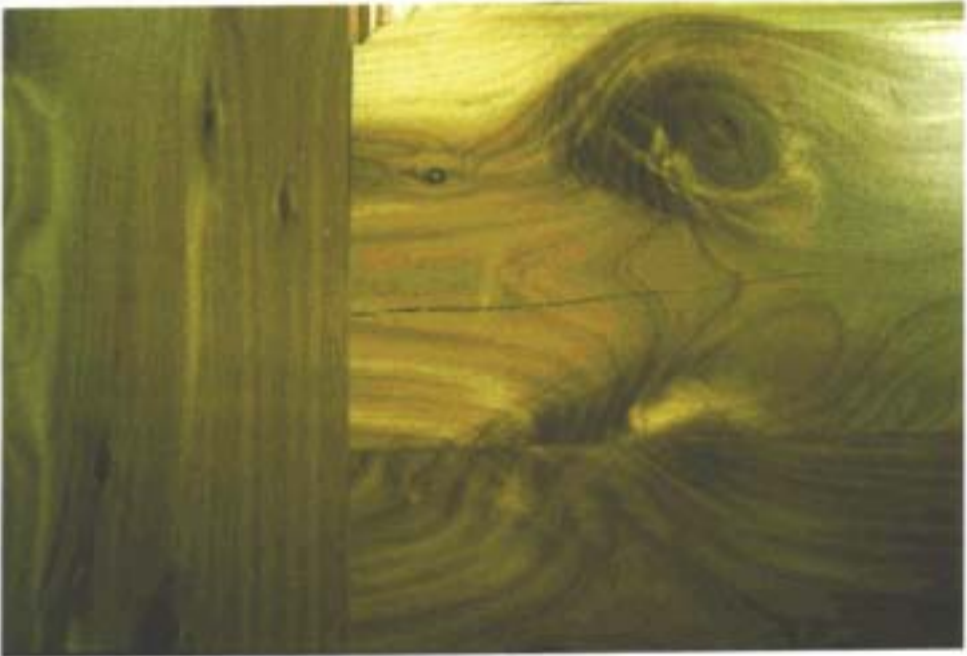
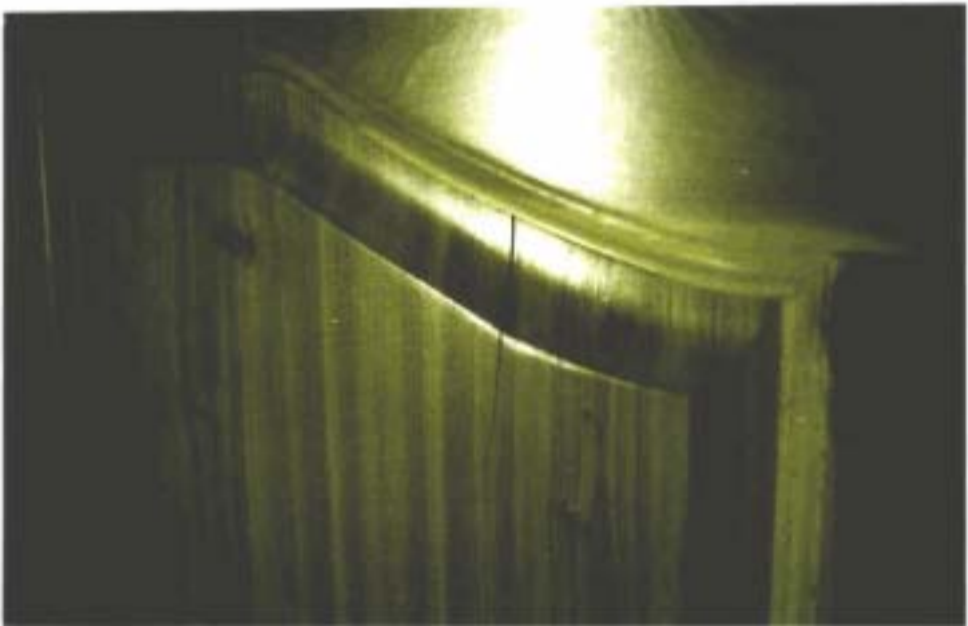
Joints opened and were exposed (photographs) and this would argue against the wood being at 2-3% MC when assembled. Some unfinished wood was also exposed on floating panels of the finished door indicating shrinkage below that when the door was finished. If the wood was assembled at this moisture content then one wouldn't expect the gaps between the joints to be as large, or the finished panels unfinished surface to be exposed, after reducing the MC from 8% to 2.5%. Again referring to the photographs, most large knots checked and there were many splits along the grain after conditioning to 2.5% MC.

Recommendations are to use wood conditioned to the MC where the doors will be put into use. Shipping and handling are very important to insure the products do not get wet or are left in a low humidity (heated in winter) environment before being put in use. Use a balanced design that includes balancing the number and size of knots from one side of the door to the other. Clearer (fewer knots, bark pockets), straighter grained wood could also help reduce the occurrence of warp. Enclosed, find a summary of a report from the Forest Products Laboratory, Madison WI on the moisture exclusion efficiency (MEE) capabilities of several paints and stains. Although none can completely impede the moisture movement in and out of wood, some are much better at doing this than others. For doors you would want to finish with a stain or paint that had a high MEE. Of course, in highly decorative doors such as Western Juniper, you want a light finish with a high MEE. Two sources that could give advice on finishes are the Forest Products Lab, Madison WI (608-231-9200) or the National Paint & Coatings Association (202-462-6272).
